# **MERCER COUNTY CHIMNEY** **SERVICE LLC.**

When should I be performing a Level 2 inspection? You Should perform Level 2 inspection when there is any change to the system. Example installing new hot water heater or furnace. When you are in the process of purchasing of a new home. Also, if you have a chimney fire. These are the most common times to have a level 2 inspection. We recommend every five years and more often if there is noticable deterioration.

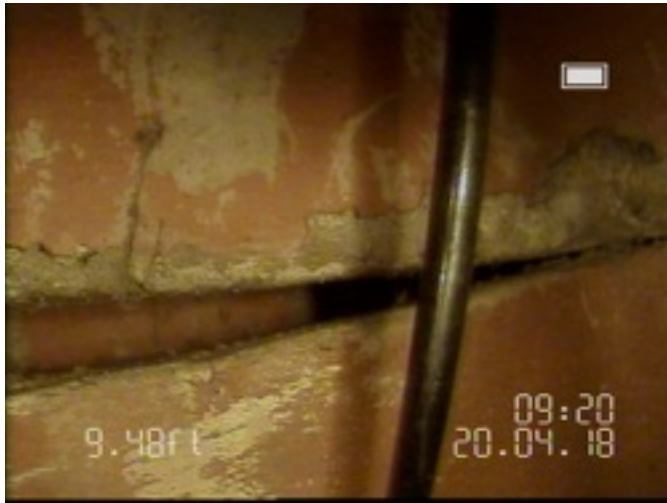
This photo was taken during level 2 fireplace was never use. Has missing mortar between terra cotta liner. A level 1 inspection would not have revealed this defect. This chimney has a metal firebox. Estimated cost to repair \$12,000.00 plus permits

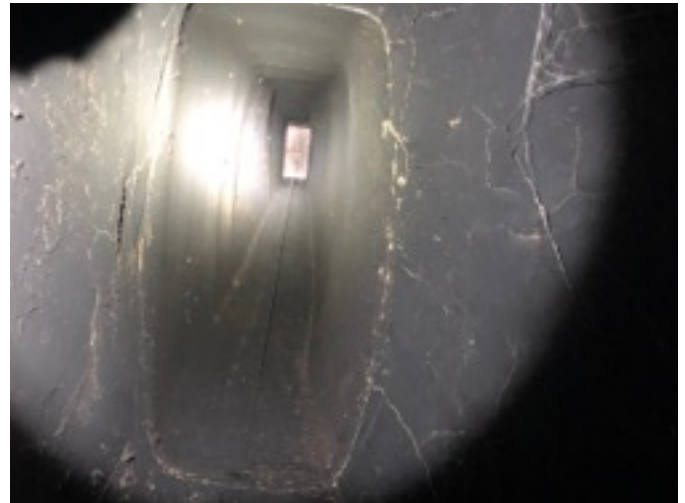
This is a photo what a level 1 inspection looks like. This fireplace was relined but without running a camera to inspect you are guessing that everything is okay rather than knowing.

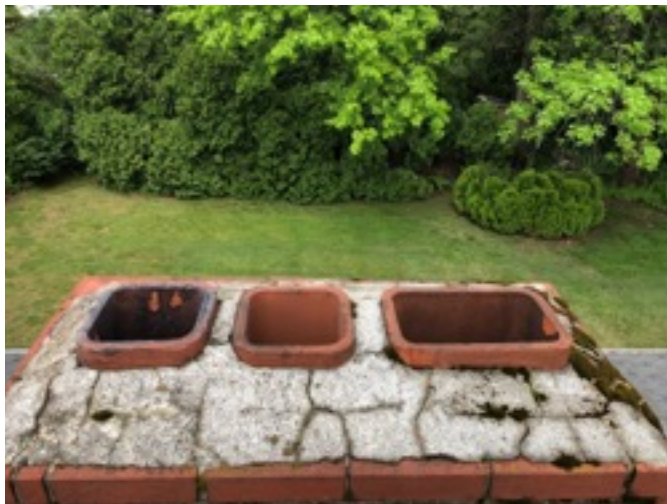
The photo above is of the crown or wash. The cracks are an easy fix now with products designed to seal. Had this gone undetected freeze thaw cycle could have caused this chimney to need a rebuild. Estimated cost to crown coat \$700.00 10 year warranty. Estimate cost to rebuild \$8000.00 10 year warranty.

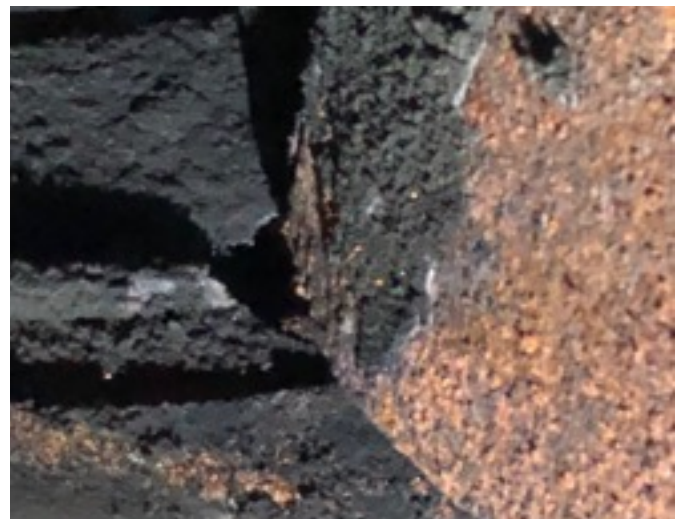
This photo is of a prefabricated fireplace that passed a level 1 inspection from another chimney company. The hole in the collar is a major problem and at this point the unit is not fixable. Estimated cost \$11,000 plus permits

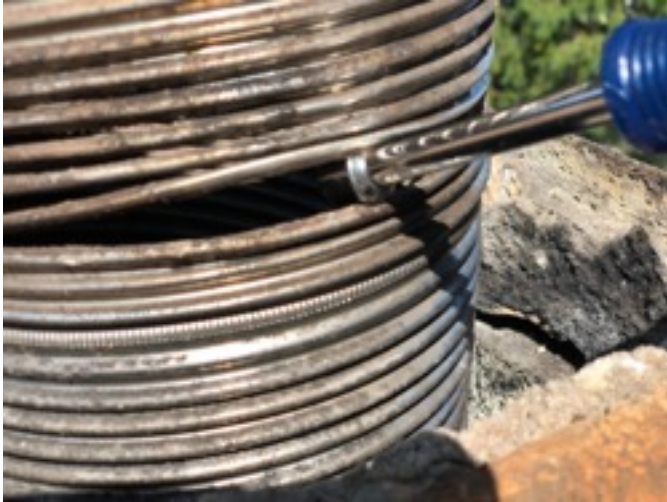
This is a stainless steel liner that vents oil flue. Looking up from the basement liner looked in good condition. Not on the roof however. Estimated cost of repair \$2300.00 plus permit.

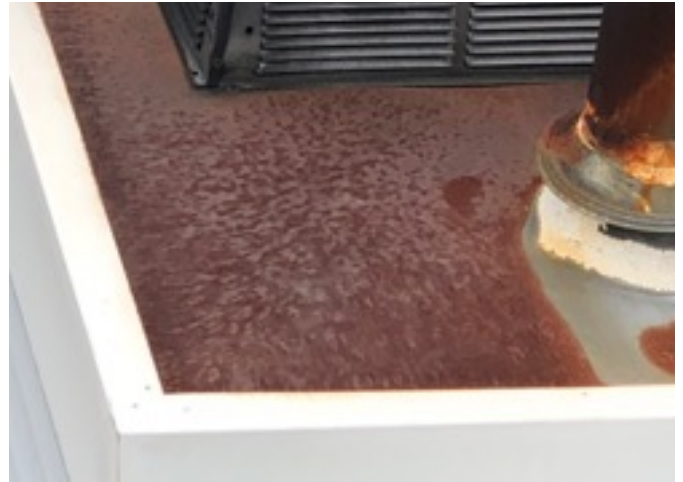
This is a prefabricated fireplace chimney top. You can not see the damage from the ground to the chase cover because to hide the ugly rust they installed aluminum white trim. This will eventually leak cause the fireplace to rust and deteriorate, possible mold growth inside the chase. New chase cover cost \$1800.00. New

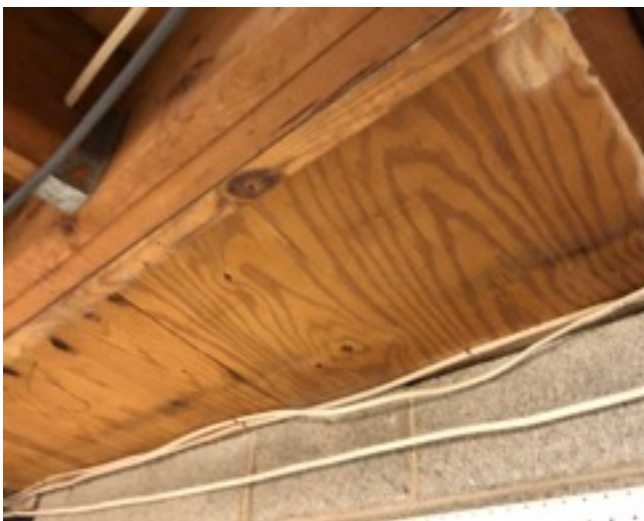
The photo above is the outer hearth of the fireplace( in front of the fireplace non combustible surface) the under side in the basement. This is a wood form that should have been removed after construction.
